PRELIMINARY TESTING OF THE DECK CONCRETE OF THE MOUNT HOPE BRIDGE

OCTOBER 2000

Joint Project by the Research and Technology Development and Materials Sections of the
RHODE ISLAND DEPARTMENT OF TRANSPORTATION
For the Rhode Island Turnpike and Bridge Authority
Prepared by Michael Sock, R&TD

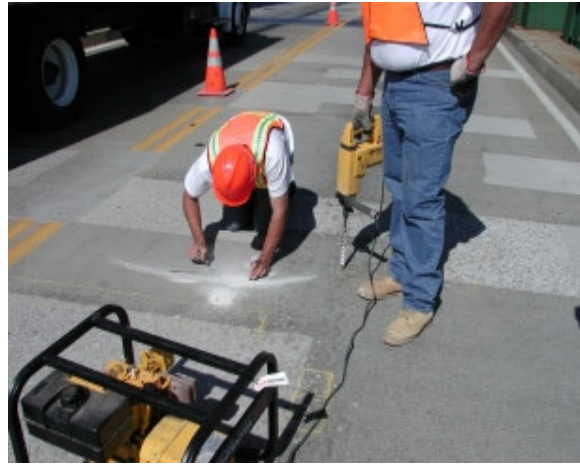
Photo 1 – Chloride Sampling

- **CONCRETE CHLORIDE CONTENT:** Chloride samples were taken to determine the extent of the chloride intrusion in the deck concrete. Three depths for each location were collected to obtain a profile (intrusion level vs. depth) of the chloride content. Chloride contents above 1.3 lbs/yd³ (in concrete with ¾" nominal aggregate) can cause corrosion of the embedded reinforcing steel. In order to get a picture of the chloride levels in the deck in three dimensions, samples were taken at various points along the length and width of the work area, as well as at varying depths.

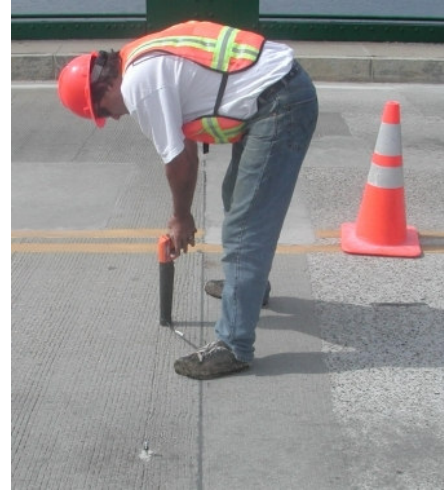
Photo 2 – Windsor Probe Testing

- **IN-SITU STRENGTH DETERMINATION:** Windsor Probe tests were used to gauge the strength throughout the deck. This involves using a calibrated load to fire a metal rod into the concrete. The depth of penetration can then be used to indicate the concrete compressive strength. The aggregate is mostly fine material and interpreting the Windsor data is normally dependent on knowing the Moh's number of the stone

in the concrete matrix, but the deck mix is closer to a mortar than a standard concrete. So it was thought that the results might be skewed. Therefore, cores for compressive strengths were taken for correlation purposes.

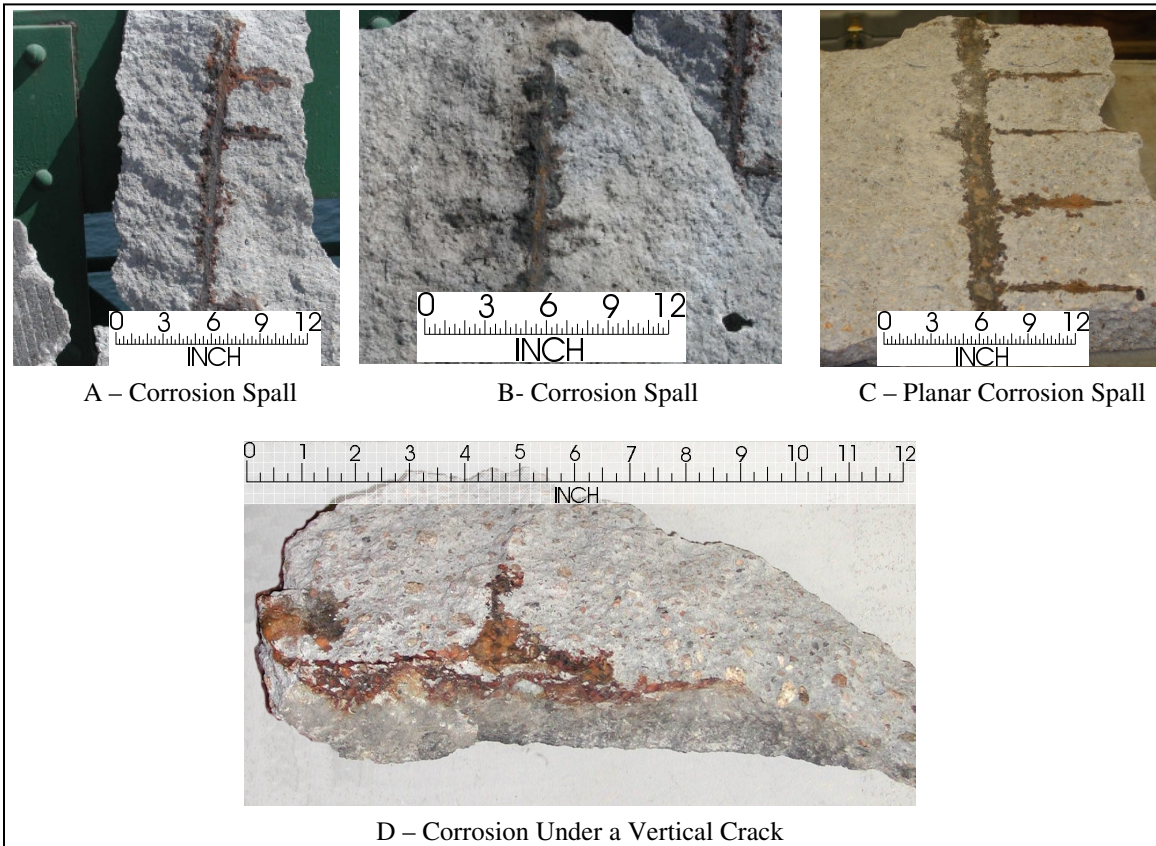
Photo 3 – Corrosion Evidence

- **VISUAL SURVEY:** A visual inspection was also performed to gain a subjective perspective of the distresses in the deck and to try to ascertain whether there is any pattern. A map of the work area was made showing the test sites and patches (See Figure 1, p. 11). The samples in the photos below exhibit significant corrosion induced spalling. Note in Photo 3D the dirt on the edge of the sample, indicating a pre-existing crack (prior to concrete removal) directly above the rust stain.

The chloride values, while much higher than they should be for fourteen year old concrete. At the top of the grid, the values are well above the threshold for the initiation of corrosion (1.3 lbs/yd³), especially in such a moist environment. That the steel is A588 would only contribute to the problem. This is borne out by the severe signs of corrosion on the concrete removed during patching.

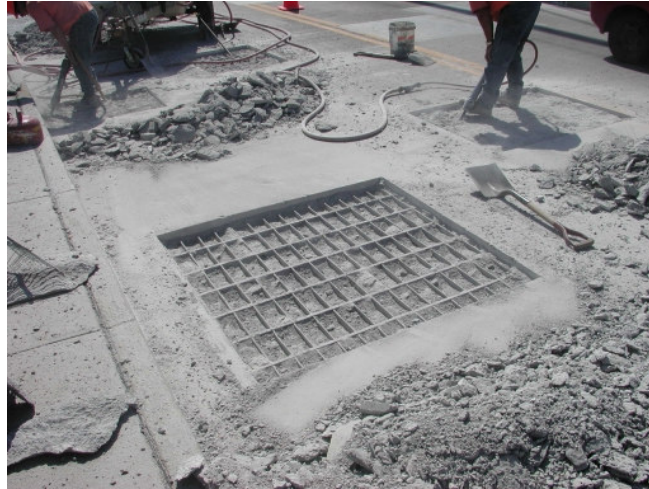
Photo 4 – Patching Operation, Showing Steel Grid

In photo 4, the repair operation is shown. The edges of the openings are clean and well formed and the grid is penetrated. Note the use of jackhammers to remove the concrete, which is common in such situations. Note also the fineness of the aggregate in the

The methods used in the current repair operations are also contributing to the problem. The specification for the patching needs to be revised. In at least one case, the aggregate used to extend the patching material was dirty and despite the longevity of the repairs, this is bad practice. There is also no quality control or assurance on the operation. Without testing of the material, there is no feedback on how well it is being produced. The workmanship on the repairs is likely the only reason they are lasting as long as they have been. Of paramount concern is the removal process for the existing concrete. The crew has been instructed to go down below the top of the grid to tie the patches into the deck more securely. As noted earlier, this process will cause microcracking in the concrete leading to further delamination. This may be why it is common for several generations of patches to be adjacent to one another. The specification for the material needs to be tightened, QA/QC testing should be required and a less damaging technique for concrete removal needs to be developed.

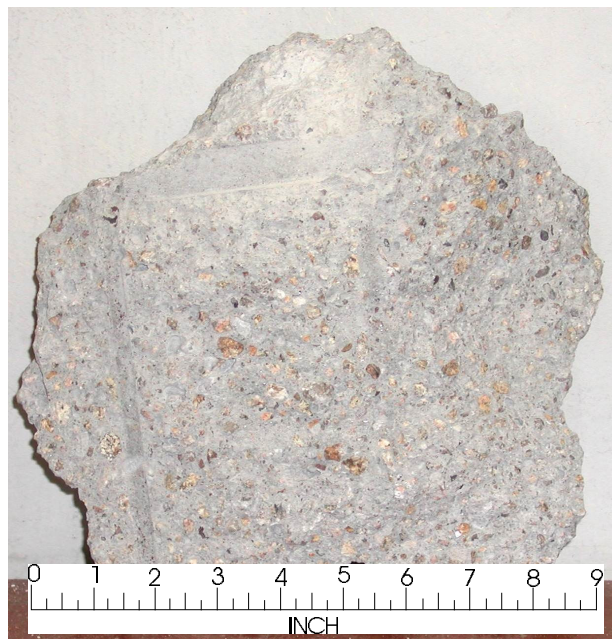
Photo 5 – Close View of Concrete Matrix

concrete in these pictures. In Photo 5, note the small size of the aggregate and the large percentage of mortar.

It is the lack of significant coarse aggregate that may be contributing to the delamination. Whatever the initial cause, once the delamination starts, there is nothing in the concrete matrix to connect the plane of the concrete over the grid to tie it to the concrete within the grid, other than the tensile strength of the concrete itself. The compressive strength is low and typically, the tensile strength is roughly ten percent of the compressive. A tensile strength 200 to 250 psi is not much to resist the forces to which the concrete would be subjected. The top of the grid is a natural fracture plane and since there is no stone that significantly penetrates the plane, there is little to stop the fracture from propagating.

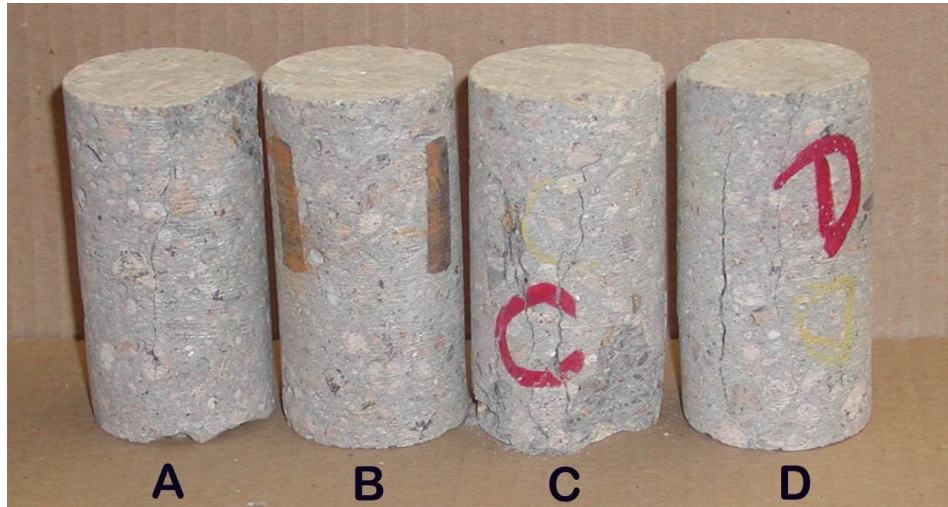
Photo 6 – Patterns of Compressive Breaks

The strength of the concrete is relatively low, although given that it is not considered to be structural (from discussions with the consultant), that in itself does not present a problem. This would be consistent with the lack of large coarse aggregate in the mix. The two higher compressive breaks seem more likely to be atypical of the concrete in the deck. This is based on the Windsor Probe results in proximity to the last two compressive cores and the overall pattern of values in the test area. The concrete strengths based on the Windsor Probe data is only an approximation, based on a correlation with the two data points where the cores and probe tests were performed in close proximity. As with any two point comparison, the correlation is only an educated guess. Since the Windsor Probe data is generally used in conjunction with the Moh's number of the coarse aggregate in the mix and there is little to speak of in this concrete, the values in the table provided with the probe were not considered to be reasonable. In Photo 6, note that the failure mode is columnar (ASTM C39, type e). This is more typical of a mortar mix, where there is little aggregate to create shear planes.

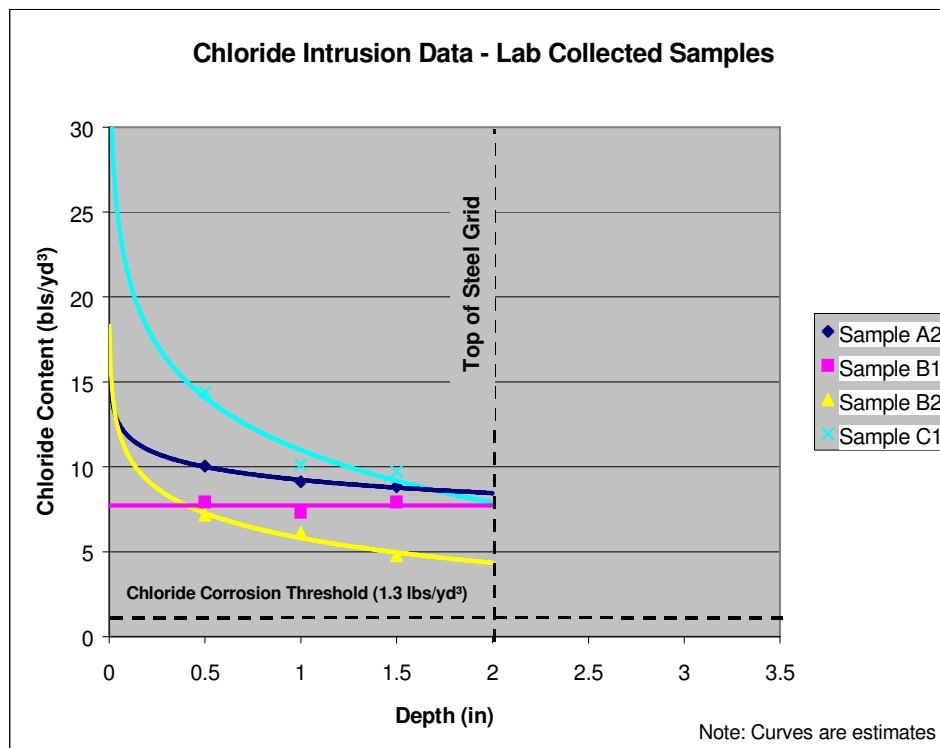
Graph 2 – Chloride Intrusion of Concrete in Lab Collected Samples

Note: There is less variation in the concrete chloride content as a function of depth in the lab samples because the differences in depth are less. The letter designation for the lab samples corresponds to the letter assigned to the large permeability cores. Some of the collected field samples were not used, as the information was seen as redundant.

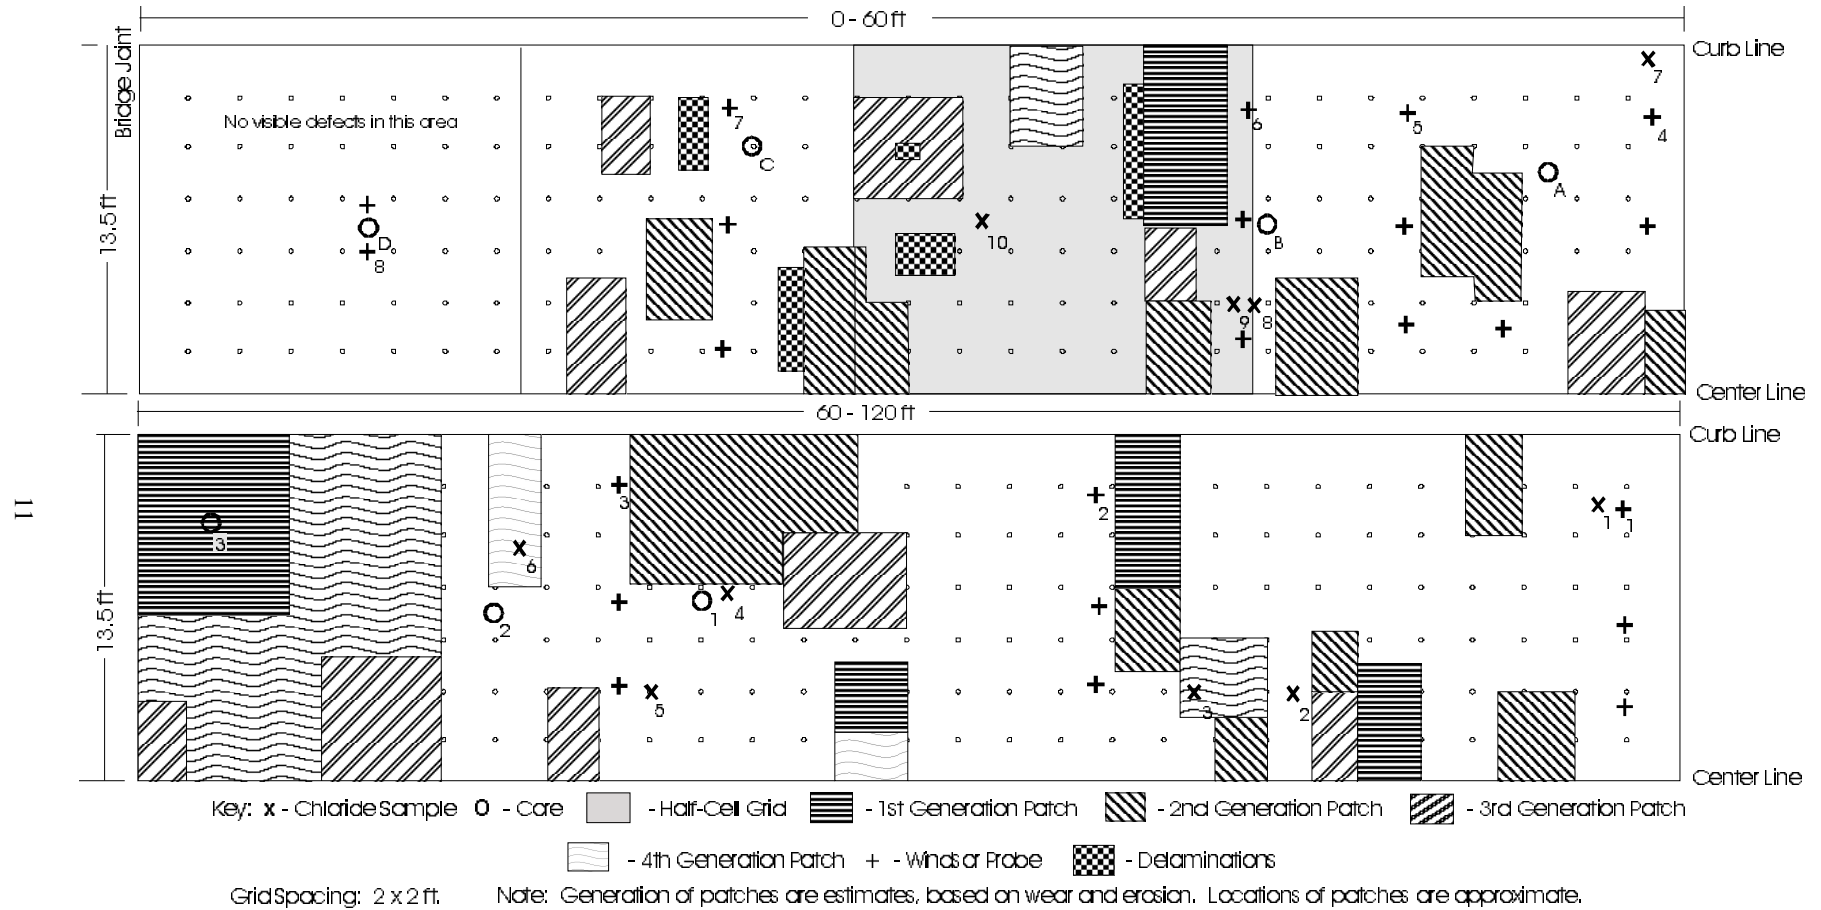
Figure 1 – Map of Defects and Sample Sites in Test Area

The deck had relatively few areas of delamination in the examined section (See Fig. 1), a testament to the thoroughness of the ongoing repair operation. Almost certainly, much larger areas would have shown up as delamined, if not for the patching. However, note that of the five delams, two were immediately adjacent to patches and two were in the near vicinity of patches. The use of the jackhammers in removing the existing concrete would tend to cause microcracking of the surrounding concrete when the steel is inevitably struck and the shock wave is sent through the grid. This could ultimately lead to further delamination. The problem is worsened by the nature of the grid system. The grid is a monolithic unit, which means that the shocks will more easily radiate in all directions. This would make the delamination effect more planar, rather than linear as in the case of rebar. The smoothness of the top of the grid also enhances the natural fracture plane.
